UNITED STATES AIR FORCE
AIRCRAFT ACCIDENT INVESTIGATION
BOARD REPORT

F-16D, T/N 88-0165

**309TH FIGHTER SQUADRON
56TH FIGHTER WING
LUKE AFB, ARIZONA**

DATE OF ACCIDENT: 26 JUNE 2013

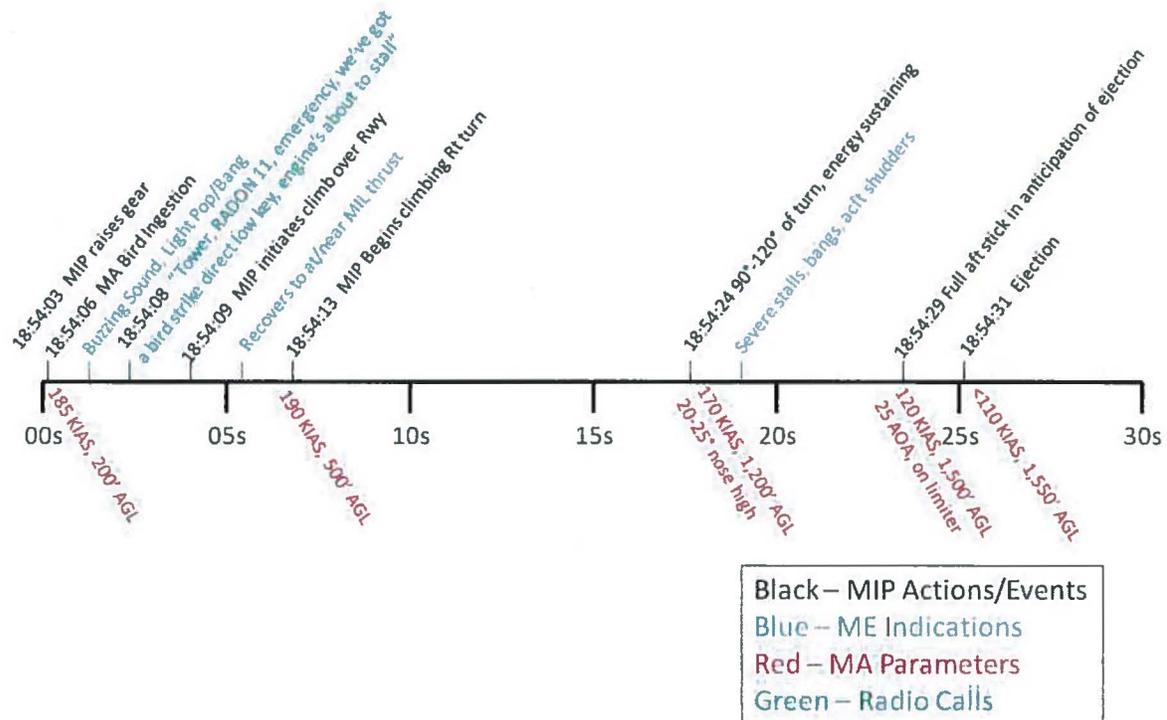
Following the ejection, the MA descended to 1,100 feet AGL and subsequently recovered to a climbing left hand turn toward the northwest (Tab FF-1). The MA reached a point 3.5-4 nautical miles north/northwest of the airfield and an altitude of approximately 6,000 feet AGL before beginning a sharp left-hand turn back toward Luke AFB (Tab FF-1). The MA then descended toward the airfield, passing HONKER 11 (providing rescue overwatch for RADON 11) from high to low, and impacted just outside the southwest fence line of Luke AFB after approximately two minutes of post-ejection flight (Tab V-5.2).

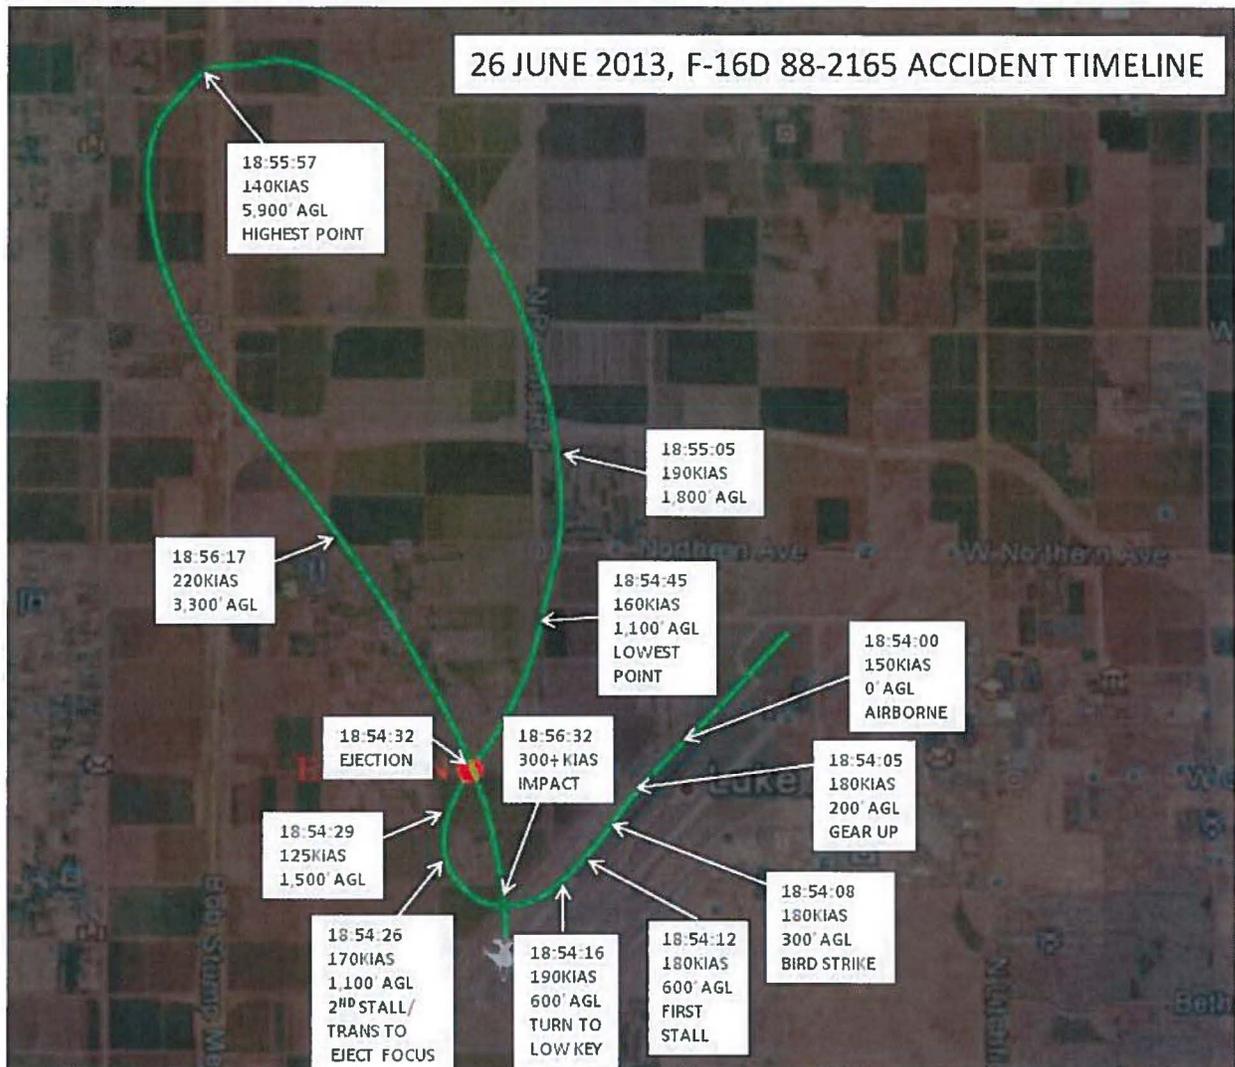
Tab FF-3

In order to assess the ability to successfully recover the MA, the TO recommended profile was flown with power settings as low as 80% in the simulator to determine whether sufficient thrust existed to sustain a straight-ahead climb. Even with continuous stalls every three to five seconds, the airspeeds achieved in a straight ahead climb provided a large enough margin in airspeed to allow the engine to recover from multiple stalls before a sink rate became unavoidable. Recovery to a key position within the known window at which the ME continued to operate (a minimum of 2 minutes 30 seconds) was also possible at power settings lower than exhibited by the ME (Tab FF-5).

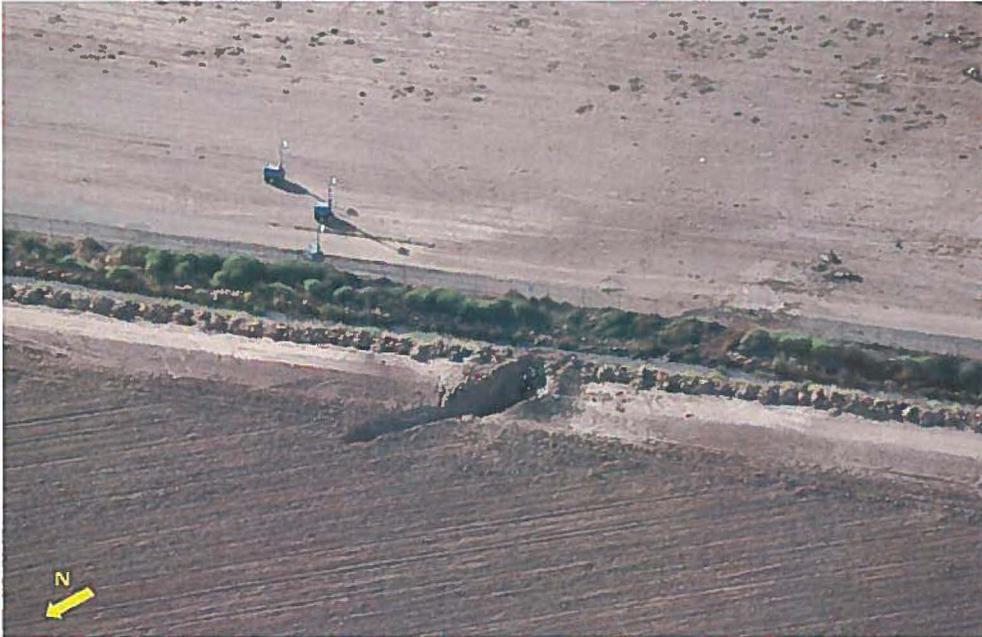
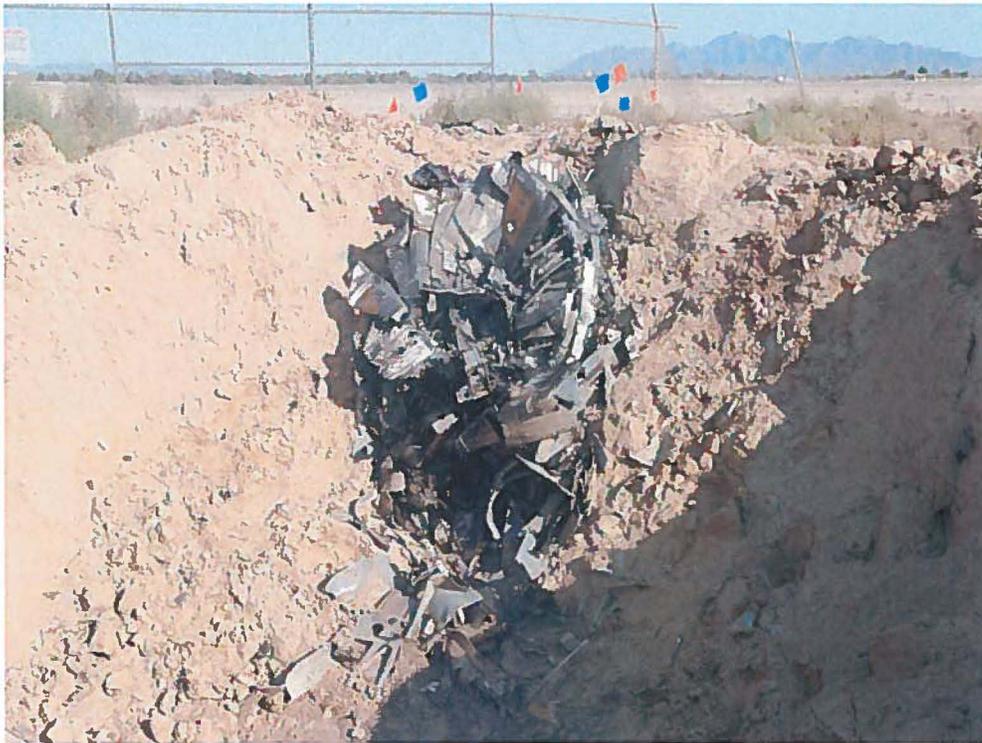
Tabs S-1, S-3

The MA impacted the terrain at approximately 1856L on 26 July 2013 at the southwest corner of Luke AFB (Tab FF-1). Estimates indicate that the MA was traveling in excess of 300 KIAS, heading 180, wings level with a low to moderate negative pitch angle at the time of impact (Tab J-12). The wreckage debris field spread south from the impact crater across the south end of Runway 21R, closing that runway until the investigation and cleanup was conducted (Tab J-12).
