**UNITED STATES AIR FORCE**  
**AIRCRAFT ACCIDENT INVESTIGATION**  
**BOARD REPORT**

**HH-60G, T/N 88-26106**

**DATE OF ACCIDENT: 12 SEPTEMBER 2013**

**EXECUTIVE SUMMARY  
AIRCRAFT ACCIDENT INVESTIGATION**

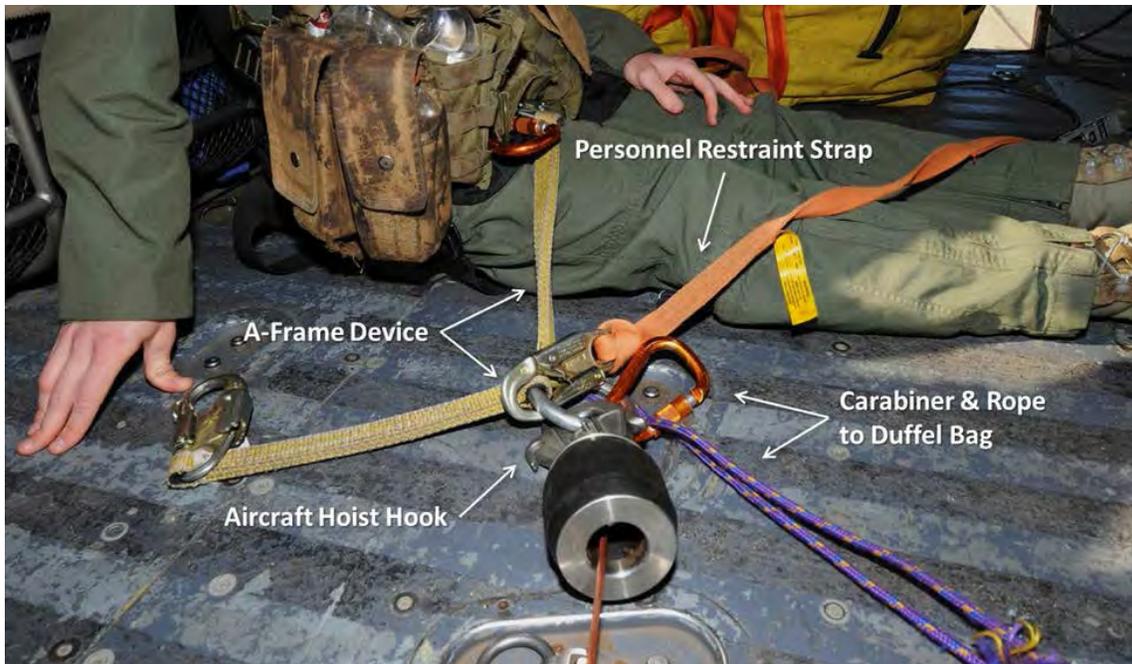
**Figure 4.1. YH with CF's CTV attached to hoist (2) (Tab Z-10)**

When the CF entered the MA cabin, the MSR handed the CF the A-Frame clasp to connect to the CF's YH load bearing D-ring (V-24.4, V-24.10, Z-8, Z-10). However, the CF mistakenly connected the A-Frame clasp to his CTV non-load bearing plastic D-ring (Tabs V-5.10, Z-20, Z-22, Z-28). The MSR then completed a visual inspection to ensure the CF was properly secured (Tabs V-5.4 to V-5.5, V-24.5). AFI 11-2HH-60V3, para 6.12.2 directs the designated Safetyman, in this case, the MSR, to "continuously evaluate the safety of the operation, and immediately inform the rest of the crew, and take the necessary action to avert a hazardous situation" (Tabs BB-14, V-24.3 to V-24.4). A visual inspection minimally met the requirement of the AFI for the MSR, as Safetyman, to "take the necessary action to avert a hazardous situation" (Tab BB-14). Due to the extremely close proximity of the YH load bearing D-ring in relation to the CTV non-load bearing D-ring, and the concealment of both D-rings by the cluttered pouches on the CTV, which included a handgun, the MSR incorrectly concluded the CF was properly secured (Tabs R-60, V-5.4 to V-5.5, Z-6, Z-30).

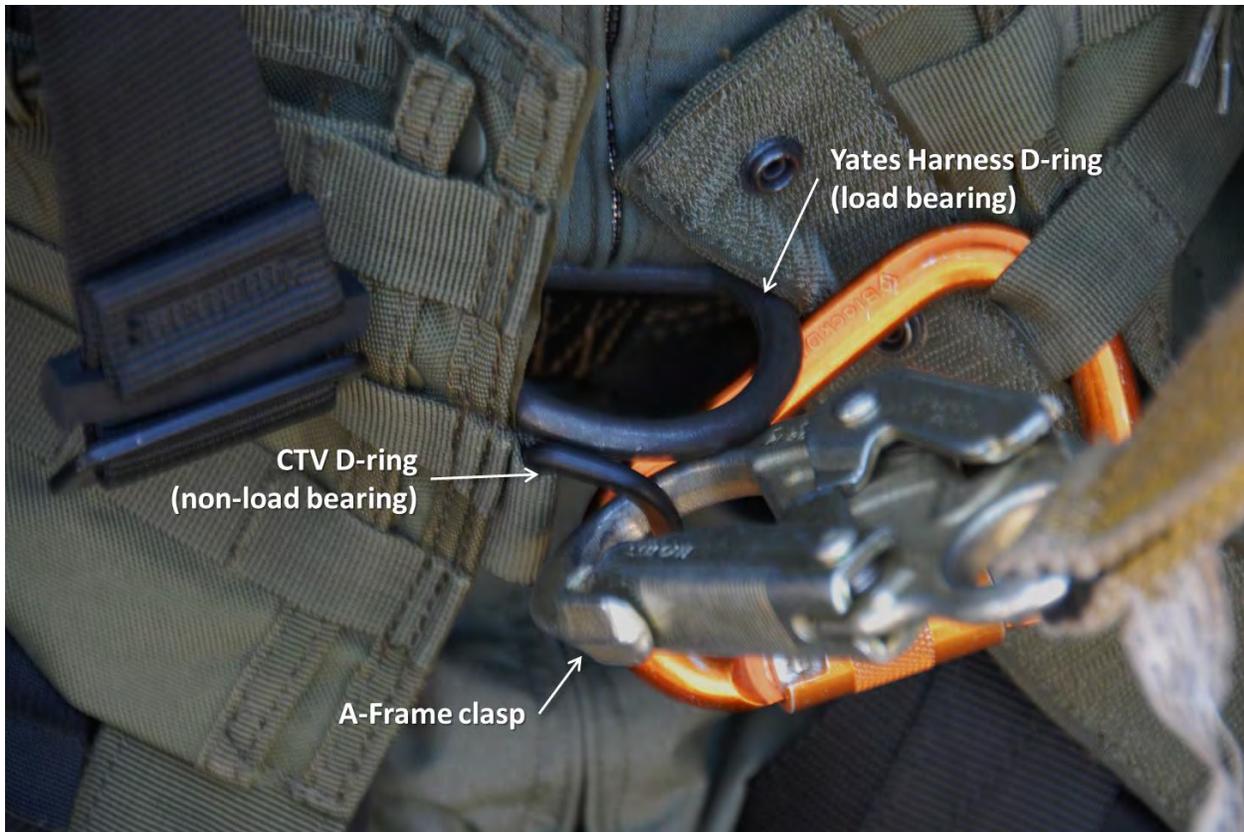
**Figure 4.2. Reenactment of A-Frame connection to CTV D-ring to show how CF was secured and the proximity of the CTV D-ring to the YH D-ring (2) (Tab Z-30)**

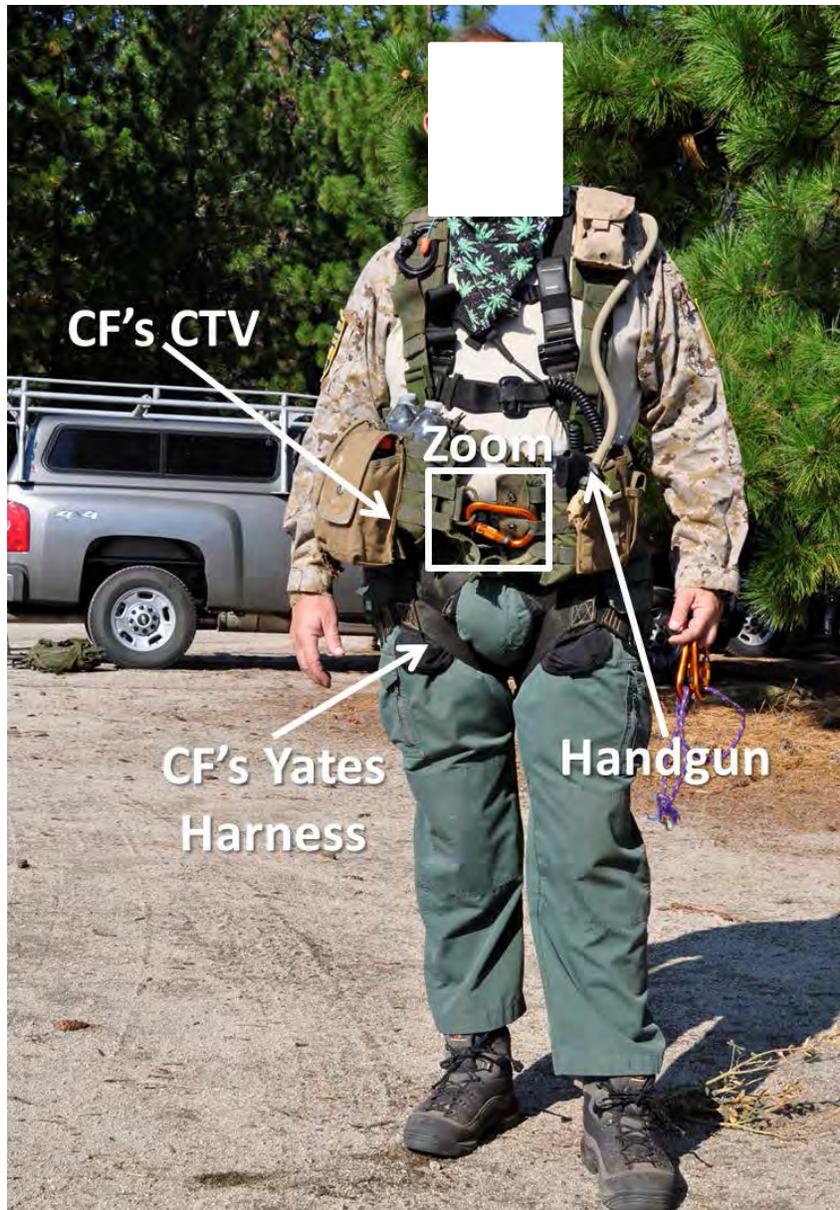
**Figure 4.3. CF configured in YH and CTV, 2 days prior to mishap (Tab Z-4)**

The photographs in Figures 4.3 and 4.4 were taken on 10 September 2013 and show the CF wearing his self-procured equipment (Tab Z-4, Z-6). The CF's equipment included a tightly secured YH around his torso with a CTV over the YH (Tabs Z-4, Z-12, Z-14). The pictures of the CF show the CTV had an intact plastic D-ring as of 10 September 2013 (Tabs Z-4, Z-6). This plastic D-ring is designed as a fastener and is not made of materials intended nor sufficient to support a person's weight (Tabs Z-20, Z-22, Z-58, Z-60). An examination of CF's CVT after the mishap found the same plastic D-ring to be broken (see left D-ring in Figure 6.1 below) (Tabs Z-22, Z-48). Using these photographs as a baseline, an identically constructed CTV was purchased and used to reenact the CF falling from the MA (Tabs Z-16, Z-46).

A picture of the CF, taken on 10 September 2013, shows the CF wearing a YH and CTV with radio, handgun, bottles of water, and other miscellanea. The picture clearly shows the CTV plastic D-ring intact. Upon examining the CF's CTV, a break in the upper corner of the D-ring was discovered. The picture also clearly shows how close the CTV plastic D-ring was to the YH load bearing metal D-ring. This configuration, combined with the CF attaching the A-Frame clasp to the D-ring by feel with the gloves he had on, led the CF to confuse the two D-rings.

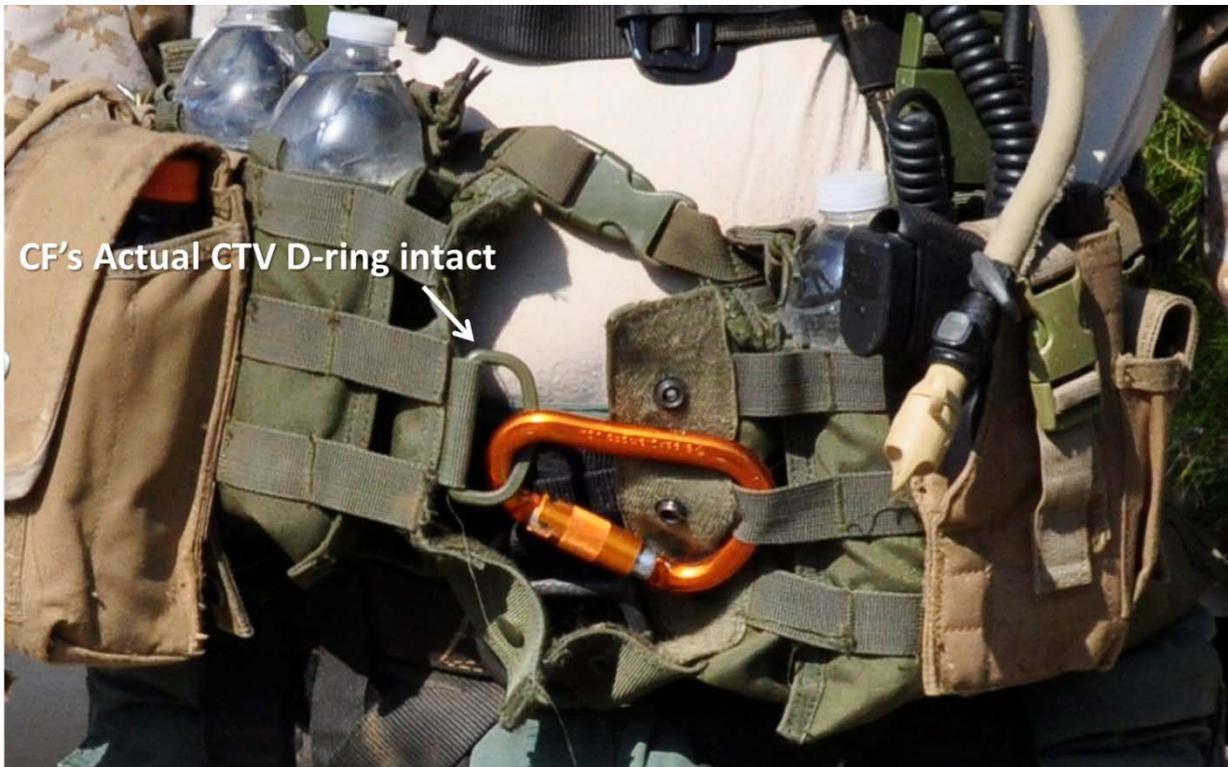
**Figure 4.4. CF CTV D-ring intact, close-up, taken 2 days prior to mishap (Tab Z-6)**

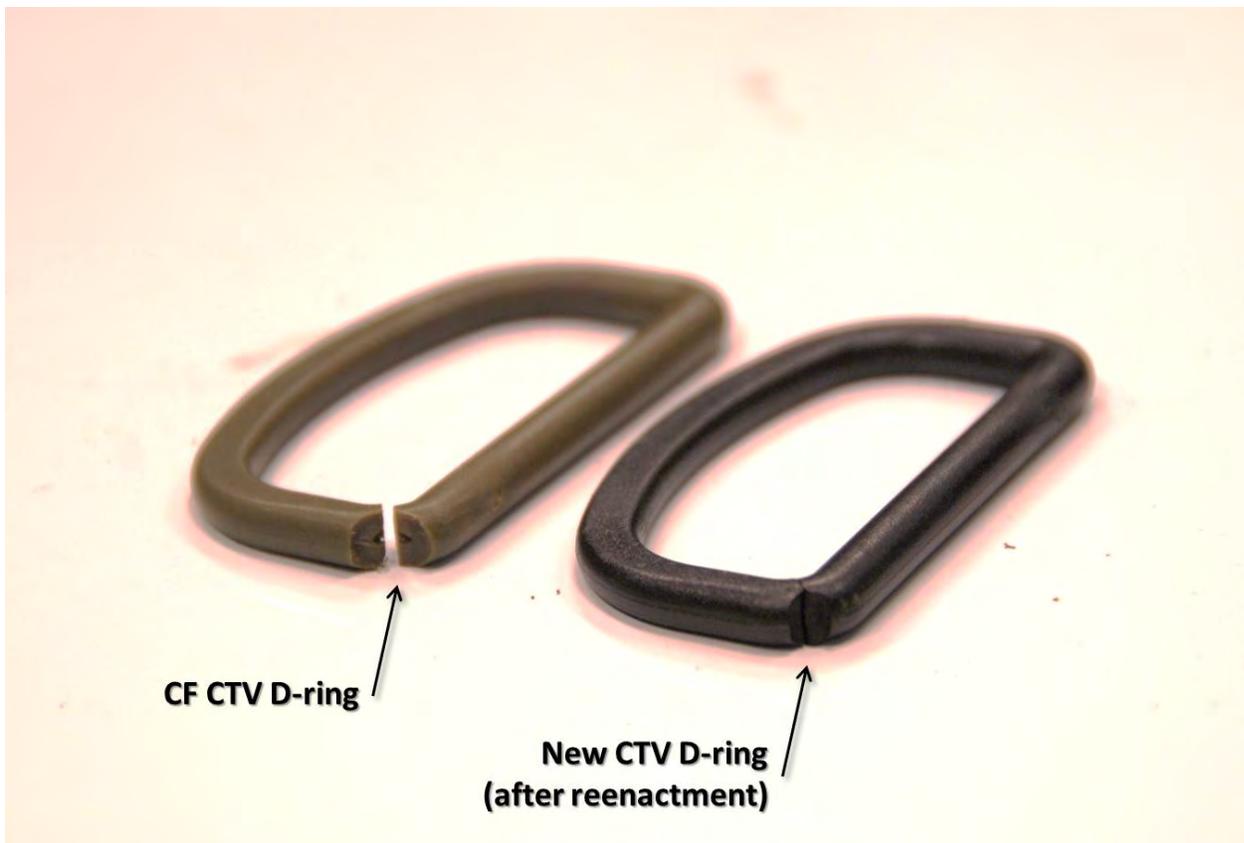
The reenactment demonstrated the ease with which an individual could mistakenly attach the A-Frame clasp to the CTV plastic non-load bearing D-ring instead of the intended YH metal load bearing D-ring (Tabs Z-4, Z-6, Z-24). Furthermore, it demonstrated that the non-load bearing D-ring on the CTV was strong enough to lift the CF out of the MA, but not strong enough to sustain the fully suspended weight of the CF (Tabs Z-40, Z-42, Z-58, Z-60). The reenactment is depicted in Figure 6.2, from left to right, showing the RA seated on the MA cabin floor, the RA being lifted out of the MA cabin, and finally the RA's CTV D-ring breaking and the RA falling while being supported by the two safety observers (Tabs Z-40, Z-42, Z-58, Z-60).

**Figure 6.1. CF's CTV D-ring and New CTV D-ring after reenactment with identical breaks (5) (Tab Z-50)**

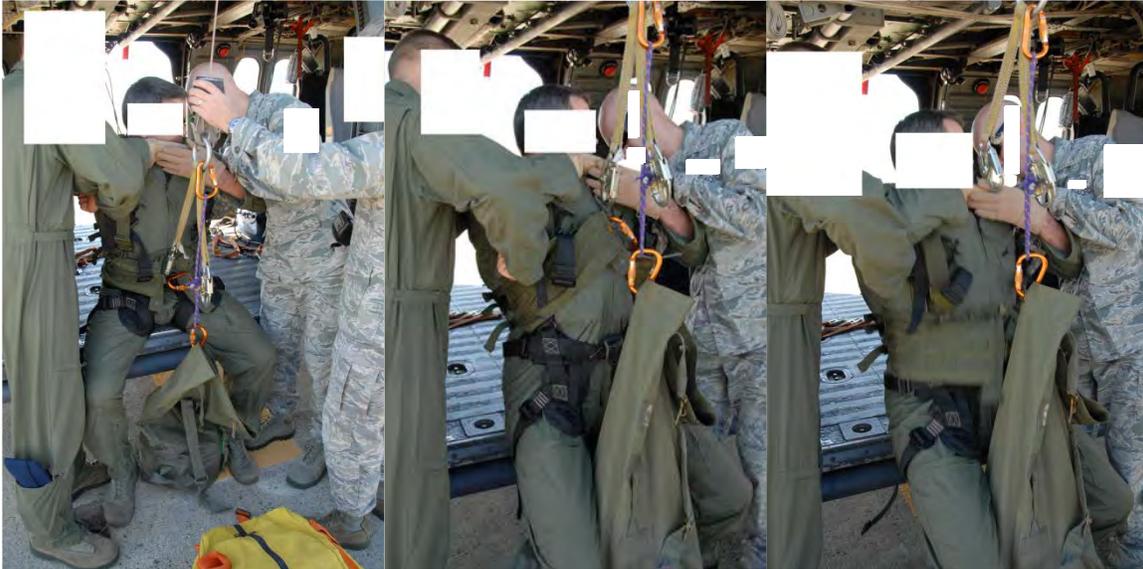
**Figure 6.2. Reenactment sequence showing 230 pound RA lifted out of MA and being suspended for a period of seconds before non-load bearing plastic CTV D-ring broke which aligns with witness testimony on how CF departed the MA.**
