STATEMENT OF OPINION

**B-1B, Tail Number 85-0091
Broadus, Montana
19 August 2013**

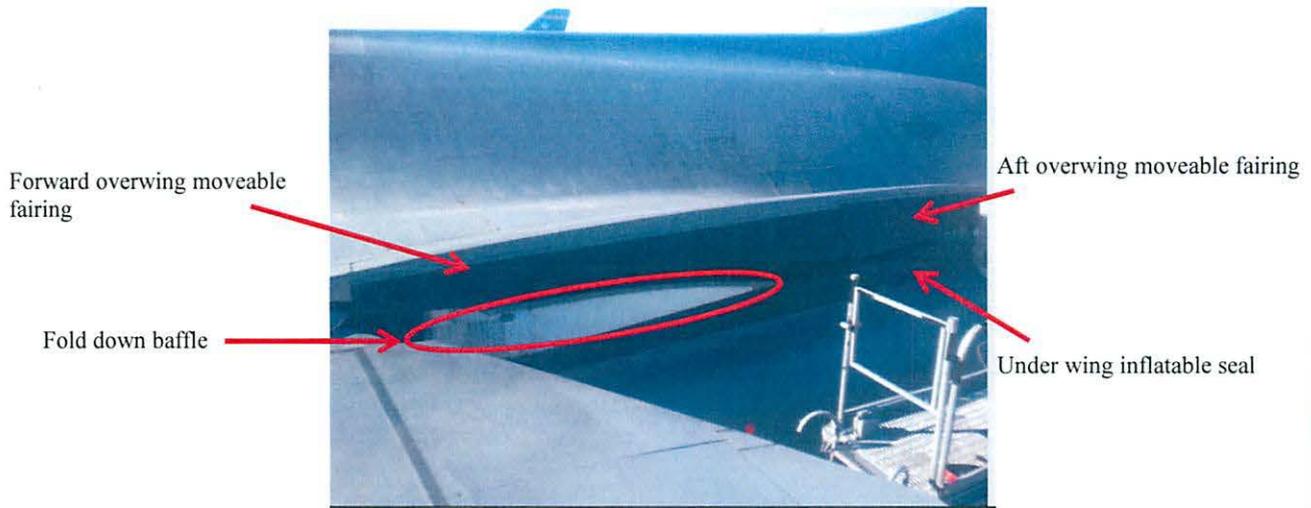
Figure 2. Side View of Left Overwing Fairing (Wing Forward).

The MA's left aft overwing fairing was found 17 miles north of the main impact site (see Site 7 of Figure 1) (Tab J-54 to J-55). It showed no signs of damage from inflight or ground fire (Tab J-77). As detailed below, a significant fuel leak developed in the left overwing fairing due to a puncture in the 4.5-inch main fuel line (Tab J-78). This leaking fuel detonated when it came into contact with a hot precooler duct, resulting in an over pressure condition in the left overwing fairing (Tab J-78 to J-80). The force from the over pressurization and wind stream caused the left aft overwing fairing to detach from the MA (Tab J-79).

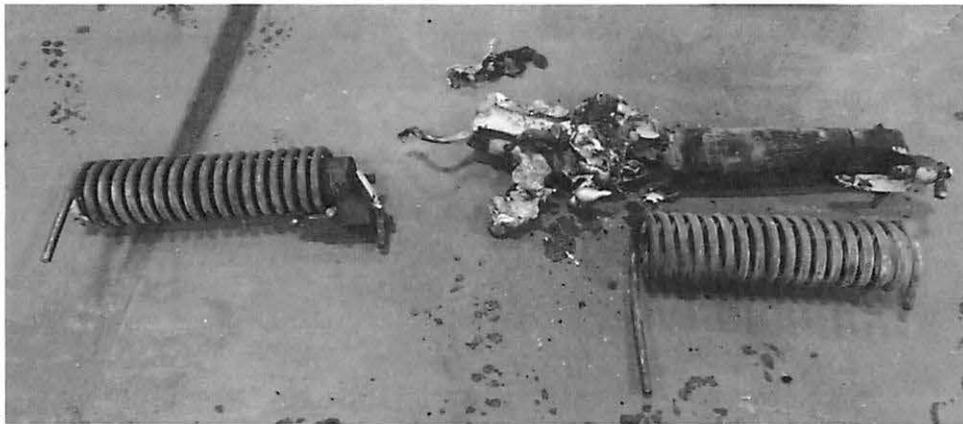
Photograph 1. Recovered Left Mandrel Spring Assemblies (Tabs GG- 3 to GG-5 and Z-22).

The left forward and aft mandrel spring assemblies from the MA were severely damaged (see Photograph 1) (Tab GG-3 to GG-5).

I considered whether the left underwing fold down baffle may have detached due to the failure of the forward mandrel spring assembly, as a possible substantially contributing factor but could not so conclude. The fold down baffle attaches to the underwing fairing at four points. Mandrel spring assemblies (forward and aft) form two of the attachment points, providing the pressure necessary to push the fold down baffle into place as the wings sweep. A forward and an aft mandrel spring assembly recovered at the crash site are consistent in form and fit with those found in the left overwing fairing cavity. Both assemblies showed evidence of structural overload, along with significant damage from exposure to fire. Of note, the forward mandrel spring assembly was missing the spring component, the interior tube was gouged and crushed, and the sheared forward mounting plate was co-mingled with a mass of melted aluminum. Thus, the cause and timing of the detachment of the left fold down baffle remains unknown.

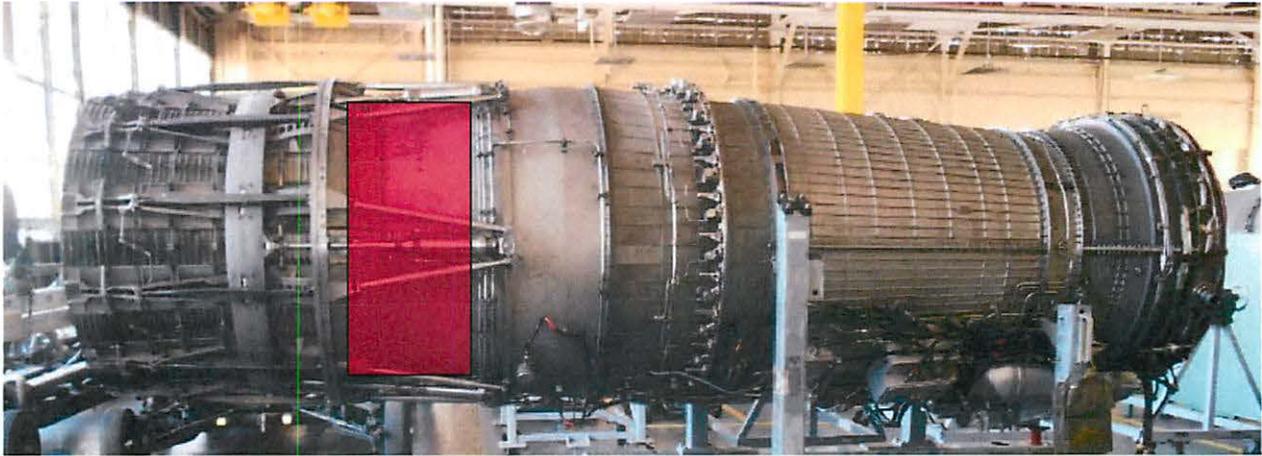
Figure 3. Location of Apparent In-flight Fire Outside of Engine 1 Highlighted in Red on Sample Engine (Tab J-32).

None of the engines from the MA exhibited any evidence of in-flight mechanical or thermal non-containment (Tab J-11 and J-31). In addition, there was no evidence of uncommanded, non-recoverable engine shutdown during flight (Tab J-31). The fire damage found between Engine 1 and Engine 2 is consistent with an in-flight fire, originating *external* to the engines (Tab J-31). All other engine damage is consistent with ground impact and post-impact fire (Tab J-31). The location of the fire external to Engine 1 is marked in Figure 3.

Engine 1. Engine 1 was operating at sub-idle speed at impact. Fire damage to Engine 1 indicated in-flight fire originating outside of the engine. All other damage to Engine 1 was

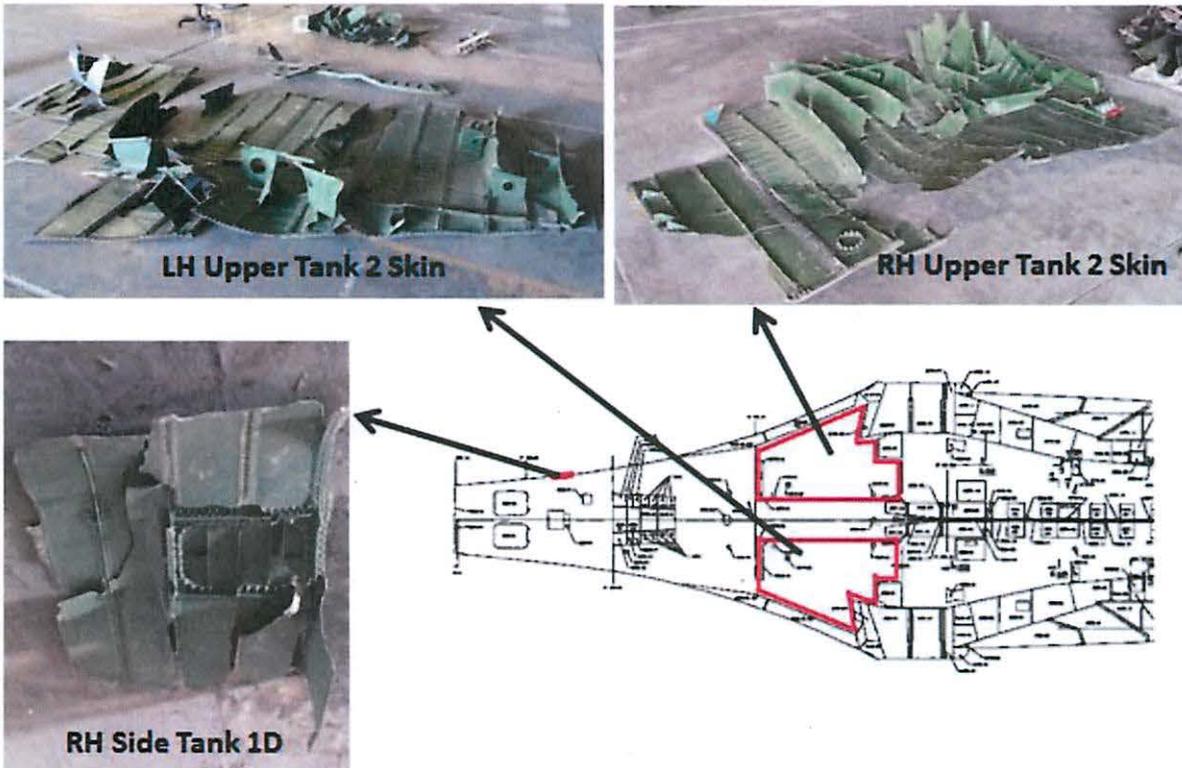
Figure 4. Debris from Tops of Tank 2A and Tank 2B (Tab J-57).

The ruptured upper skin of Tank 2A, Tank 2B, and Tank 1D found at Site 5 (see Figure 4) indicate an in-flight overpressure condition in the fuel vent system (Tab J-80). Over 90 pieces of Tank 2A and Tank 2B were recovered at Site 5 (J-76). Site 5 is located just under 4.5 miles from the main impact site and approximately 12.5 miles from Site 7 where the left overwing fairing was located (Tab J-54). There was no evidence of ground fire at Site 5, and all of the recovered pieces were relatively clean, lacking any evidence of being involved in a typical hydrocarbon-fed in-flight fire (Tab J-56).

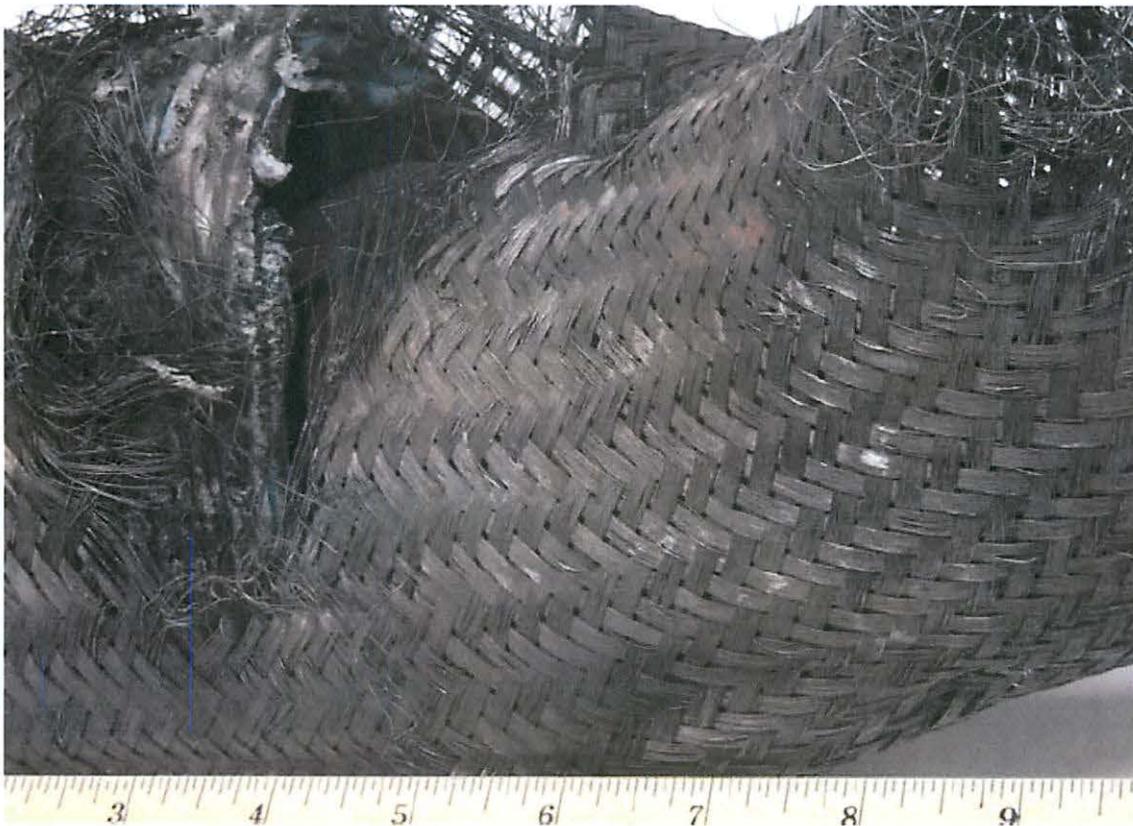
Photograph 2. Damage to 4.5-Inch Main Fuel Line (Tab J-122).

The 4.5-inch main fuel line from the MA's left overwing fairing was recovered from the crash site and exhibited extensive damage (Tab J-108 to J-110). Specifically, the line had a v-shaped cut to the top half of the fuel line (Tab J-108 to J-110 and J-122). Analysis suggests the v-shaped cut resulted from impact from an external object (Tab J-109).

The 2-inch fuel cooling loop line and 4.5-inch main fuel line (see Diagram 3) from the left wing root bay were submitted to the Air Force Research Laboratory at Wright-Patterson AFB, OH, for analysis (Tab J-107). The 2-inch fuel cooling loop line showed evidence of line collapse due to thermal exposure (Tab J-107 to J-108, J-113, and J-115). The 4.5-inch main fuel line showed multiple fractures and melting of the inner layers of the line, likely due to thermal exposure (Tab J-108 to J-109). In addition, the 4.5-inch main fuel line had a v-shaped cut (see Photograph 2) through the exterior braiding and into the inner layers of the line (Tab J-109).

This type of damage suggests the 4.5-inch main fuel line had been cut by impact with an external object (Tab J-109).
