UNITED STATES AIR FORCE
AIRCRAFT ACCIDENT INVESTIGATION
BOARD REPORT

MC-12W, T/N 09-0676

361ST EXPEDITIONARY RECONNAISSANCE SQUADRON
451ST AIR EXPEDITIONARY WING
KANDAHAR AIRFIELD (KAF), AFGHANISTAN

DATE OF ACCIDENT: 27 APRIL 2013

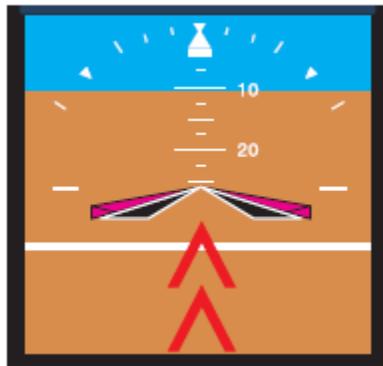
Figure 2. Declutter Display (Tab BB-30)

When an MC-12W's pitch angle exceeds 30 degrees nose-up or 20 degrees nose-down, or bank angle is greater than 65 degrees, the "declutter" function automatically removes non-critical information from the PFD. Additionally, warning chevrons appear, cueing the pilot to pull towards the depicted artificial horizon (see Figure 2). This mode automatically removes all data from the PFD with the exception of red chevrons that indicate which direction to maneuver the aircraft for safe recovery if the necessary data is being received by the AHRS to generate chevrons. The PFD reverts to the normal display when pitch angle is returned to less than or

equal to 25 degrees nose-up, 15 degrees nose-down, and 60 degrees bank angle (Tab BB-30 to BB-31).

In both “Declutter” and “NCD” display modes, the chevrons cue the pilot to raise the nose of the aircraft towards the horizon. Though this is useful in most unusual attitude conditions, it is opposite the direction of initial input required to recover from both spins and spirals (Tab DD-56).

Turn and slip indications are the only way spin direction can be reliably determined when flying in instrument meteorological conditions (IMC), or “in the weather” where reference to flight instruments are necessary to determine aircraft attitude, and they are critical for correct, prompt spin recovery (Tab DD-57). Airspeed indications are used to differentiate spin from spiral, and execute appropriate recovery methods (Tab BB-22). Neither turn and slip nor airspeed is available in “NCD” mode (Tab DD-57).
