UNITED STATES AIR FORCE
AIRCRAFT ACCIDENT INVESTIGATION
BOARD REPORT

B-1B, Tail Number 85-0091

DATE OF ACCIDENT: 19 AUGUST 2013

SUMMARY OF FACTS AND STATEMENT OF OPINION
B-1B, Tail Number 85-0091
19 AUGUST 2013

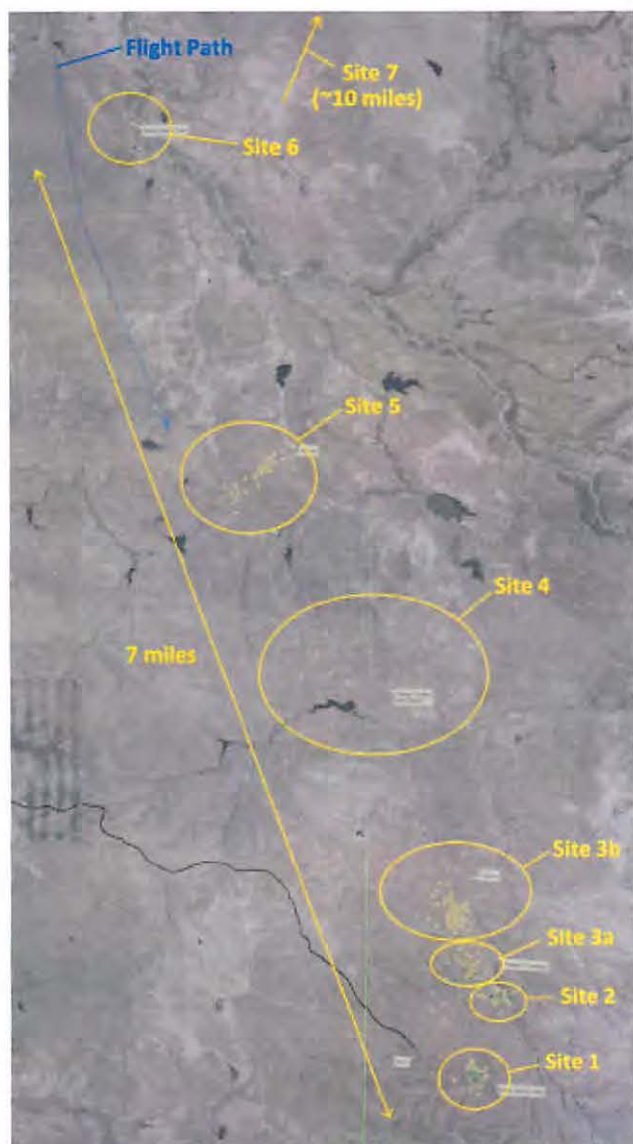
Figure 1. Crash Sites (Tab J-53 to J-64).

The MA impacted the ground at approximately 0916L (Tabs J-67 and FF-7). Debris from the MA spread over a 17-mile area of privately owned, grass-covered pastureland within the MOA, approximately 24 miles east of Broadus, MT (Tab J-53 and J-71). Distinct groups of MA parts were found along a path generally headed in a northwesterly direction, which eventually changed to a southeasterly direction (Tab J-71 to J-72). The debris spanned Site 1 to Site 7 in Figure 1 (Tab J-54). The forward portion of the MA separated and impacted approximately 1.5 miles from the main crash site (see Figure 1) (Tabs H-7, J-54, and J-72).

SITE 1: Wing carry-through box structure, wings, main landing gear, engine nacelles, engines, and aft fuselage (Tabs J-61 to J-64 and Z-3 to Z-13)

SITE 2: Forward equipment bay, cockpit, nose landing gear, and central equipment bay (Tabs J-61 and Z-13 to Z-14)

SITE 3A: Bottoms of Tanks 2A and 2B, nose radome, crew entry ladder, and pieces of intermediate weapons bay doors (Tabs J-60 and Z-15 to Z-17)

SITE 3B: Sections of intermediate weapons bay and Tank 2 side walls, approximately 15 feet of tunnel bay above intermediate weapons bay, and pieces of intermediate weapons bay doors (Tab J-59)

SITE 4: Ejection seats, escape hatches, refueling tube from Tank 2, and an access panel from the tunnel bay above Tank 3 (Tab J-58)

SITE 5: Tops of Tanks 2A and 2B, numerous frames from Tanks 2A and 2B, and pieces comprising a section from the top of Tank 1D (Tabs J-56 to J-57 and Z-17 to Z-18)

SITE 6: Aft half of panel from the left overwing fairing (Tab J-55 to J-56)

SITE 7: Overwing fairing bumper, bottom of left aft nacelle, and the left aft overwing fairing (Tab J-55)

Figure 1 details the location of debris from the MA. Upon impact at Site 1, the main portion of the MA disintegrated, resulting in the immediate release of the remaining fuel and other combustibles (Tabs J-61 to J-64, J-72, and Z-3 to Z-13). Burning at the north end of Site 1, where the wings and main carry-through box impacted, was more intense than at the south end (Tab J-72). The fires self-extinguished because of the remote location of the crash site (Tab J-72).
