STATEMENT OF OPINION

**B-1B, Tail Number 85-0091
Broadus, Montana
19 August 2013**

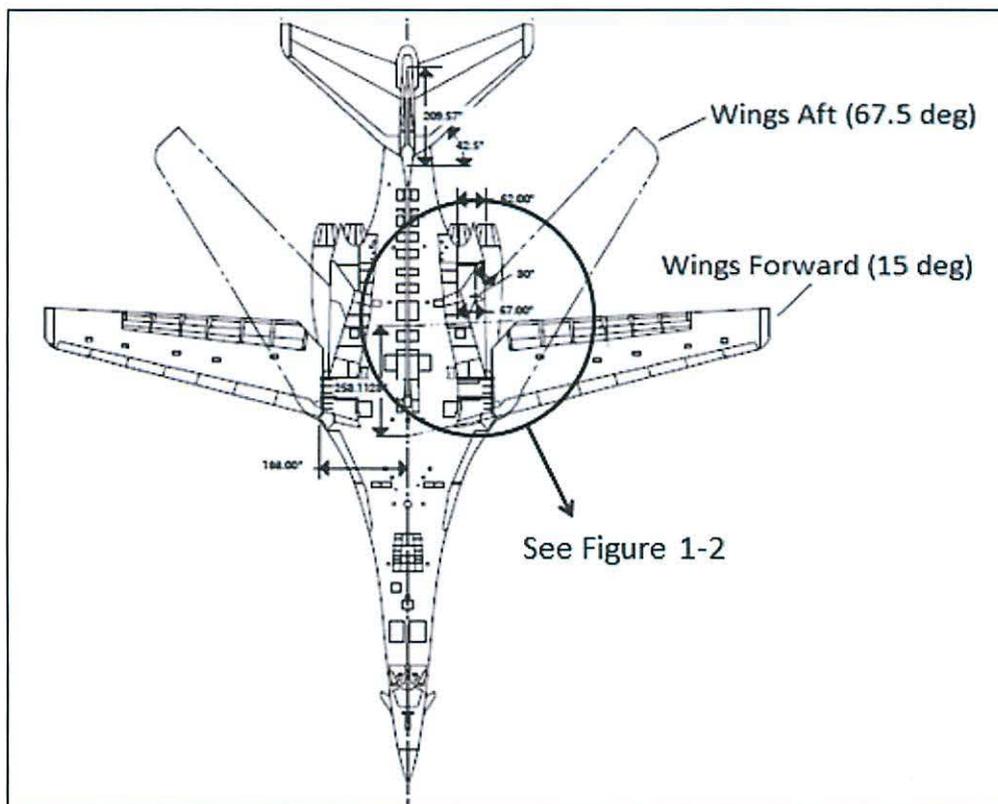
Diagram 1. B-1B Wing Sweep (Tab J-33).

During aft wing sweep, only the wing and the fold down baffle move inward into the overwing cavity (see Diagram 1). The overwing fairings house the 4.5-inch main fuel line, the 2-inch fuel cooling loop line, the fuel cooling blower, the overwing fairing fire detection loops, multiple aircraft wire harnesses, and hydraulic lines (Tabs J-38 to J-39 and J-47 to J-49; T.O. 1B-1B-2-27GS-00-1).

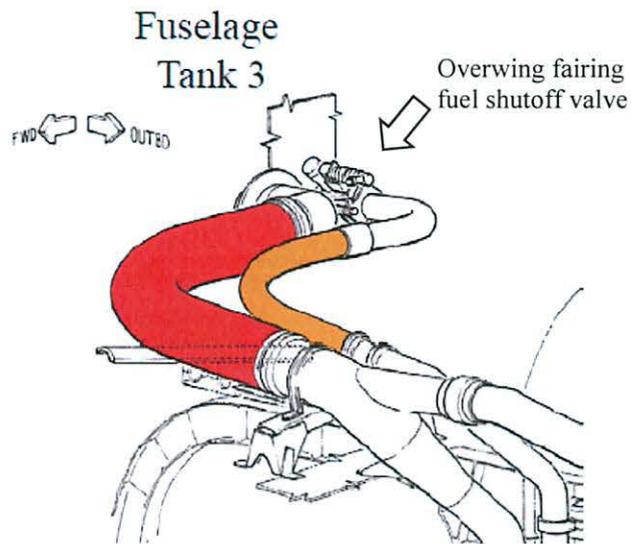
Diagram 3. Two-Inch Fuel Cooling Loop Line (Orange) and 4.5-Inch Main Fuel Line (Red) (Tab J-113).

The 2-inch fuel cooling loop line and 4.5-inch main fuel line (see Diagram 3) from the left wing root bay were submitted to the Air Force Research Laboratory at Wright-Patterson AFB, OH, for analysis (Tab J-107). The 2-inch fuel cooling loop line showed evidence of line collapse due to thermal exposure (Tab J-107 to J-108, J-113, and J-115). The 4.5-inch main fuel line showed multiple fractures and melting of the inner layers of the line, likely due to thermal exposure (Tab J-108 to J-109). In addition, the 4.5-inch main fuel line had a v-shaped cut (see Photograph 2) through the exterior braiding and into the inner layers of the line (Tab J-109).

This type of damage suggests the 4.5-inch main fuel line had been cut by impact with an external object (Tab J-109).
